APPLICATION REPORT ON

**“Anticorrosion Coating Application On Internal
of kiln Shell”**

AMBUJA CEMENTS, KODINAR, GUJRAT

PROJECT REPORT ON: “Anticorrosion coating application on internal of kiln shell”

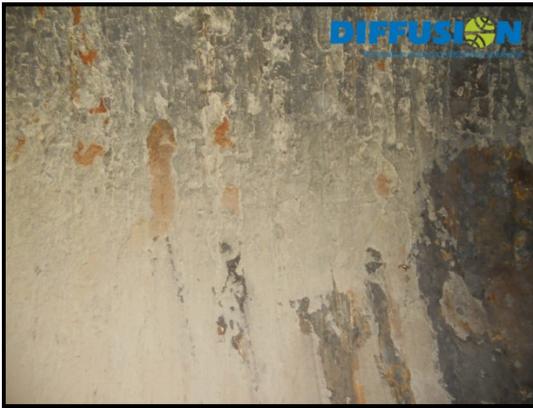
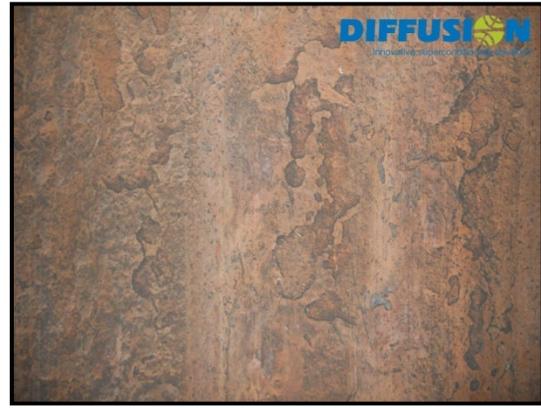
1. Hard and Brittle Scale deposit were observed across the Kiln shell.

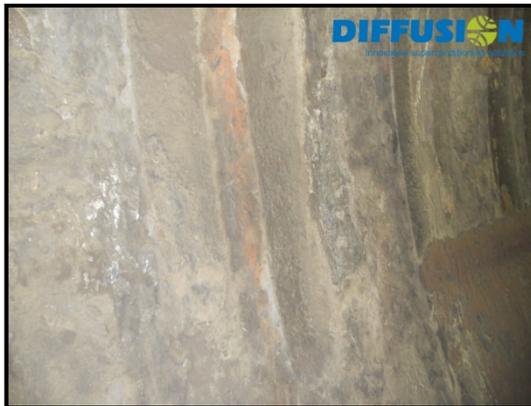
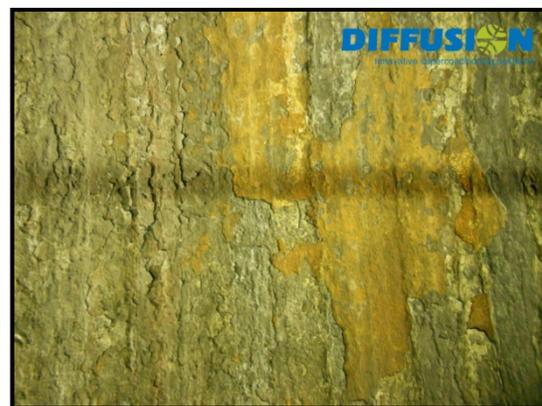
2. Scaling observed was in concentric ring and each ring having width of approx of 4 to 5 inch in wave form.

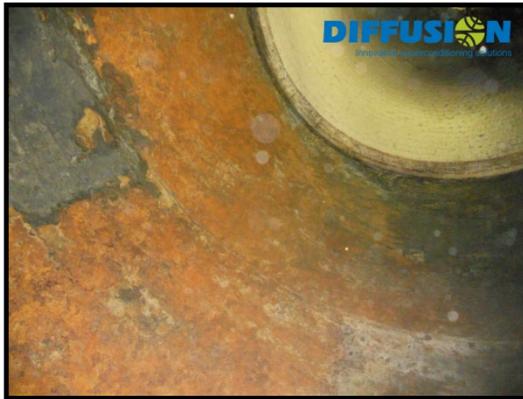
3. More scaling was observed from 31m Length 38m to Length (from KILN INLET) Scale thickness was approx 3 to 4 mm and difficult to remove. The Scale was difficult to remove by Chipping and also by Hammering. Once scale was removed, reddish yellow & Black color deposit was visible.

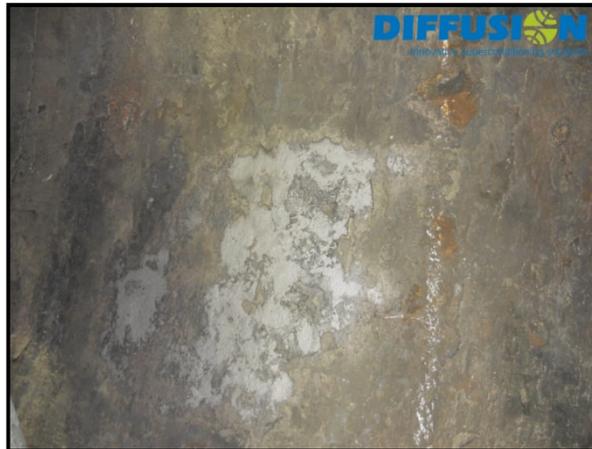
- a. As the Surface had hard scale deposit on surface, initial blasting with Abrasive grit did not show any significant removal.

- b. Based on above fact it was decided to carry out Chipping with Chisel and hammer across the allotted Kiln area for coating. Removal of scale in the area of Length between lengths 31m to 38m was difficult.
- c. Abrasive Grit Blasting of the surface was started on from 29m to 38m was continuous For 48 Hrs.
- d. After Complete Hard Blasting entire scale were removed.
- e. Left over scale were again removed by Chipping and again blasted.
- f. Final Sweep blasting was carried out on to remove Flash rust on the surface.

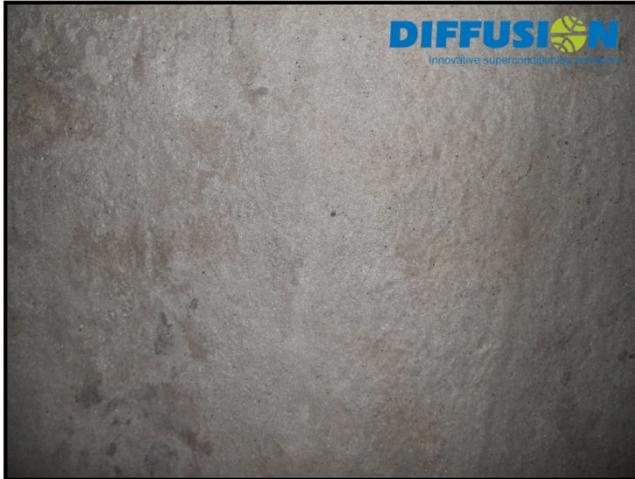
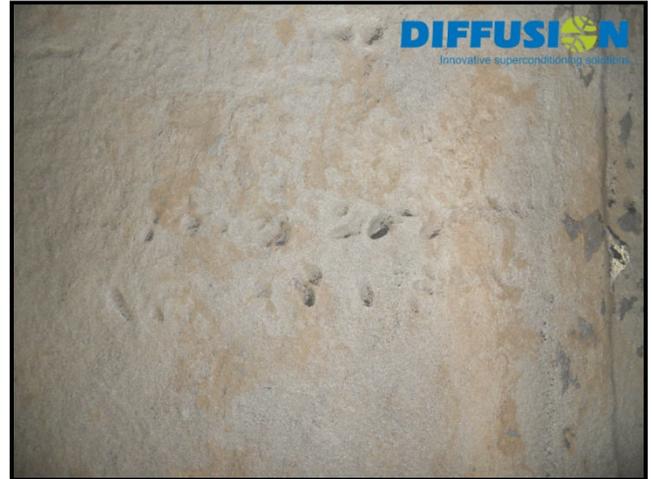
- g. Final Blasted surface reveled the base surface as
1. Large no of corrosion pits were observed on the surface. Some pits were area large as 4-5 cm and depth as high as 4 mm

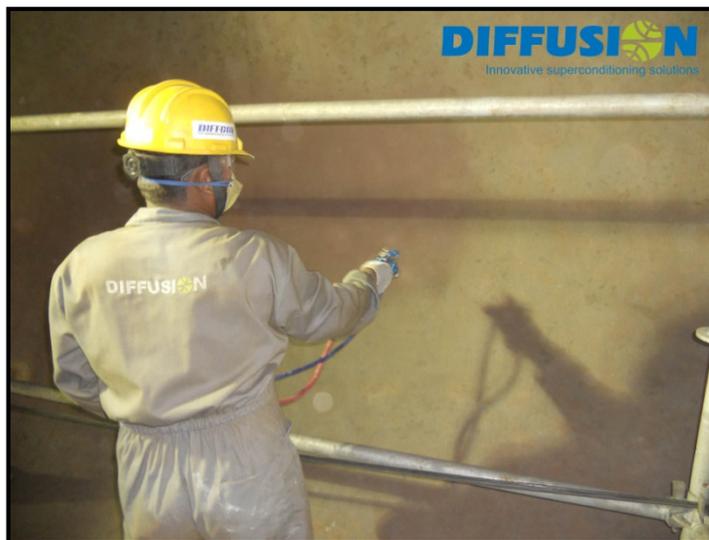
1. Kiln Guard 600 scw material was mixed to get uniform color and dispersion without any lumps.
2. Material were mixed in given ratio of one container of base to one container activator.
3. Mixed material were spayed using pressure pot gun to have uniform coverage on surface.
4. Distilled water was Used 1 liter Max to adjust Viscosity .
5. Coating material was applied in Two coat of average WFT (wet Film Thickness) measuring 300 Micron using Pressure POT Spray equipment . As surface was uneven the Material thickness showed irregular reading.
6. The Dry film Thickness measure after fist coat application was appox on average 175 to 200 Micron
7. As material consumption was on Higher Side due to uneven Base surface It was decide to spray material evenly on allotted kiln shell area.

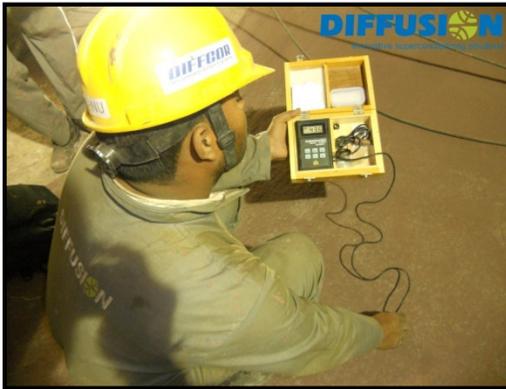
DFT On Point 1

1. The Final DFT Measurement showed Coating thickness of 350 micron. The DFT measurement was made on 4 POINTS on Diameter at interval of 1 m throughout the length.
