REPORT NO: DCQ/NGP/2020-21/07

APPLICATION REPORT

INTERNAL COATING OF REVERSE AIR BAG HOUSE (RABH)

**ACC LIMITED, CHANDA CEMENT WORKS, CEMENTNAGAR
CHANDRAPUR (MAHARASHTRA)**

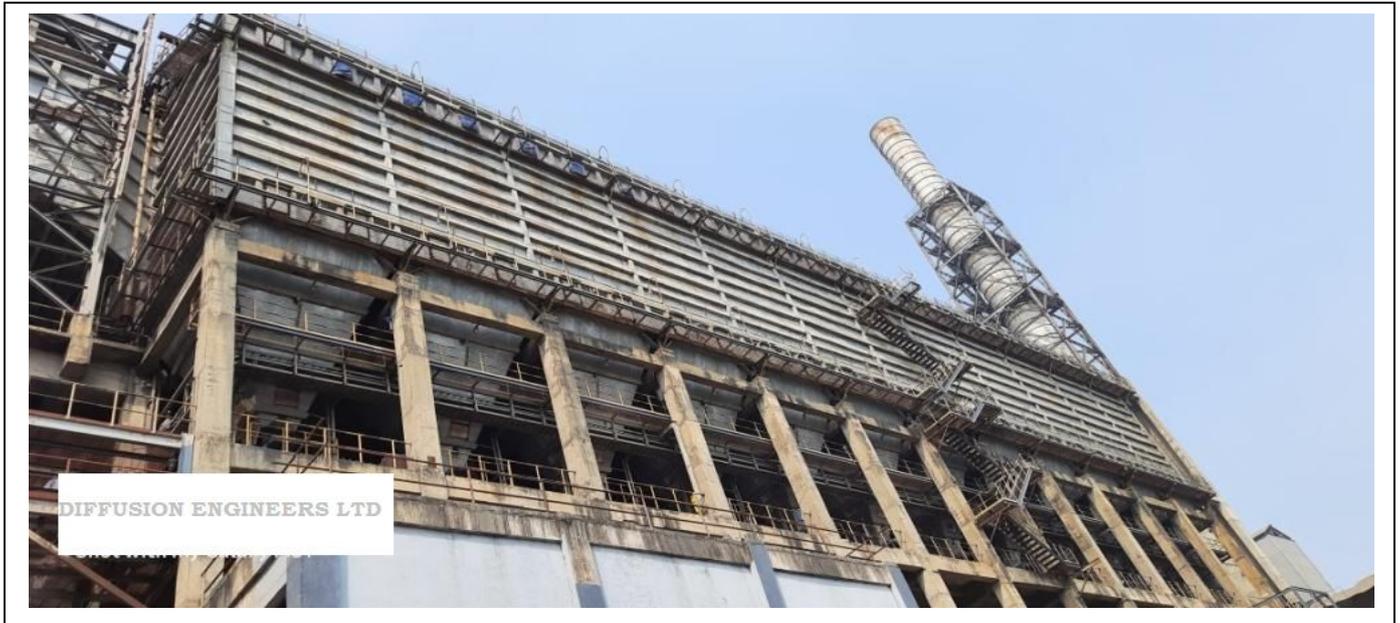
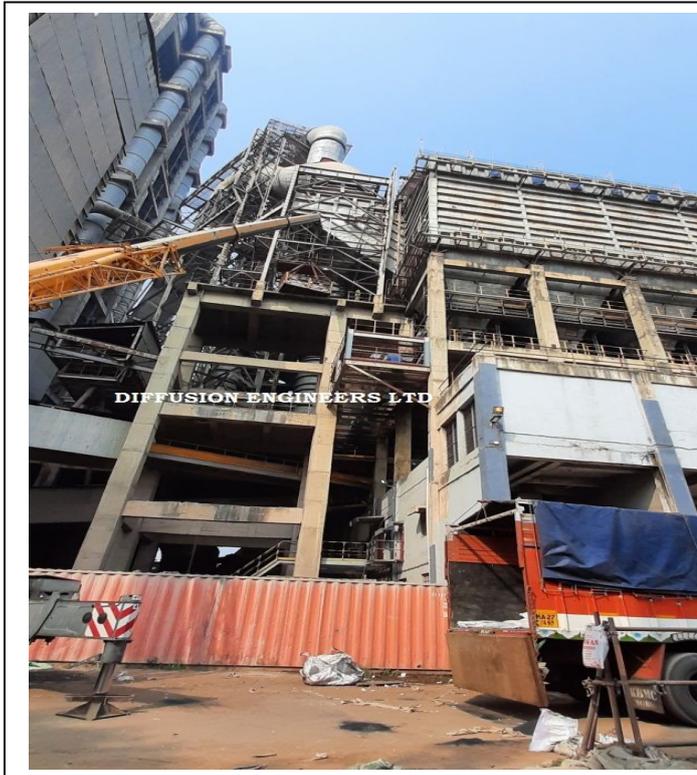
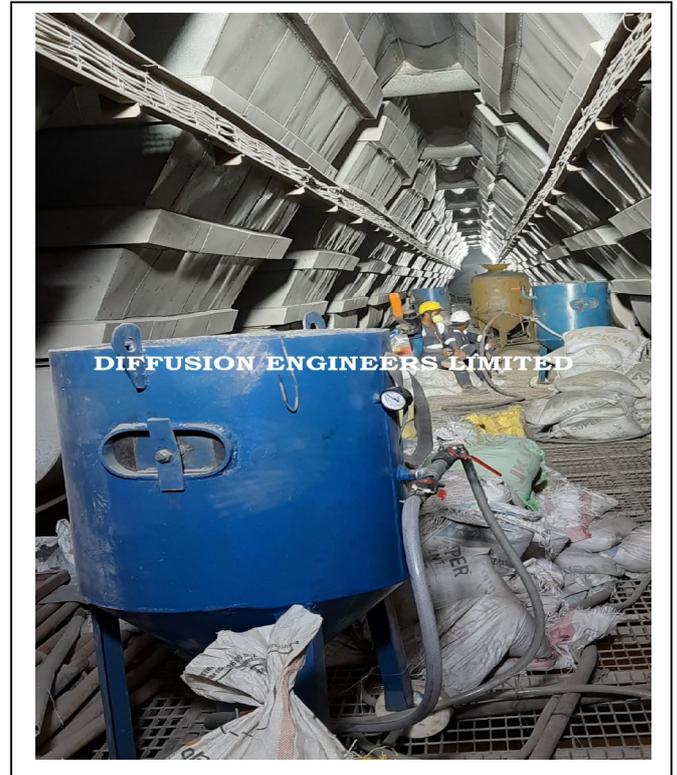
Actual Site Images

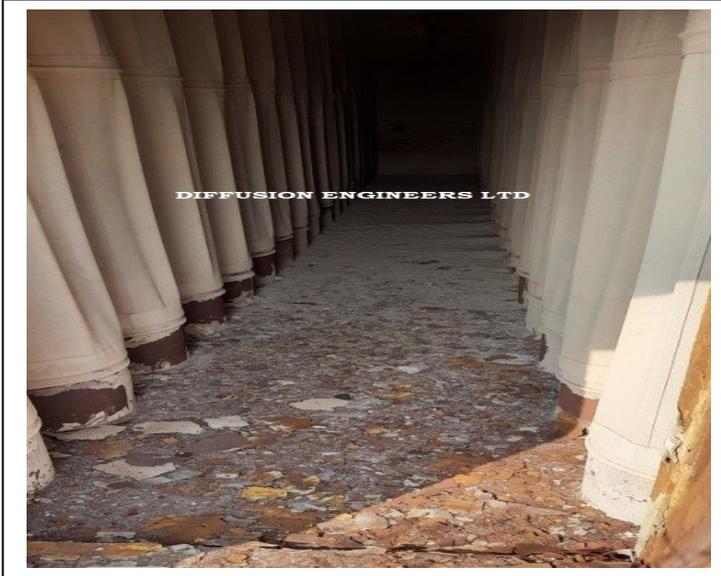
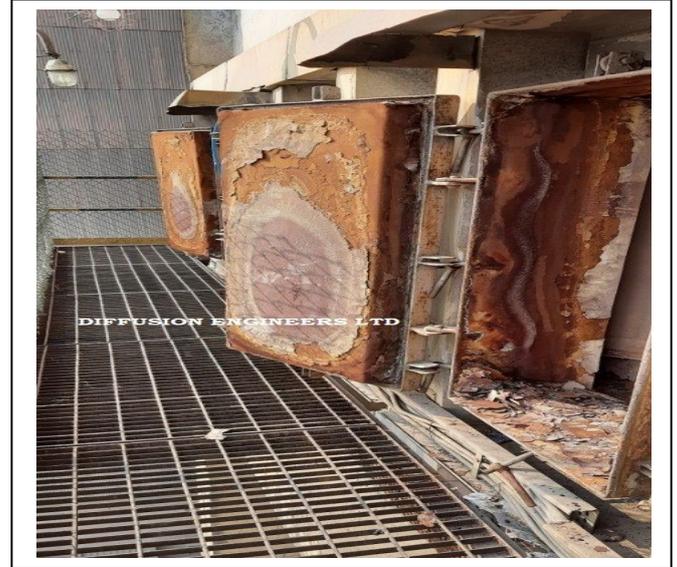
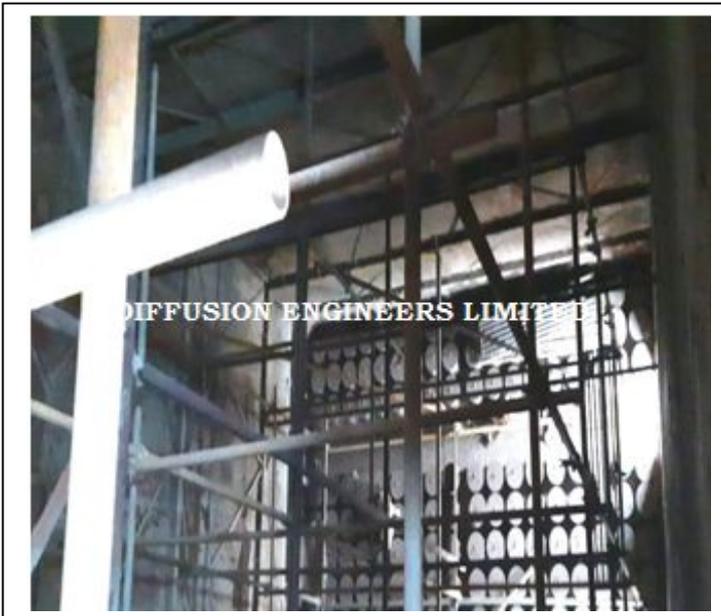
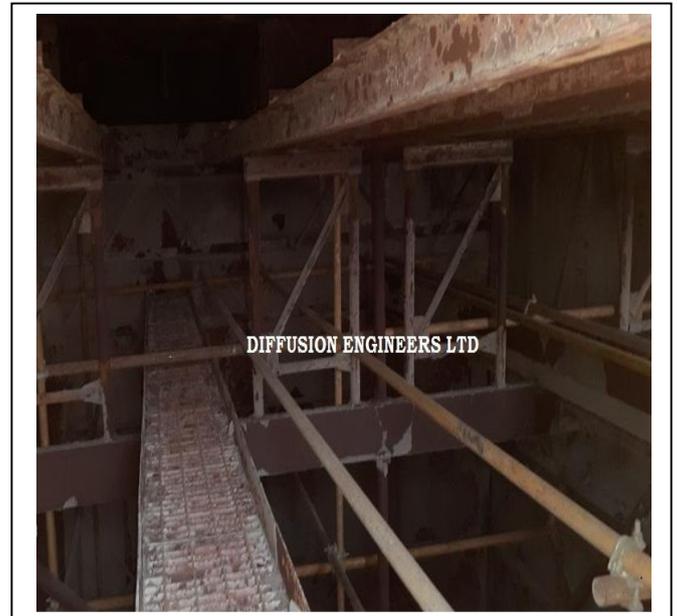
Customer was facing severe corrosion problem in bag house. i.e. corrosion on the wall of bag house, corrosion on the roof of the bag house corrosion on the floor of bag house. After a certain period, Pits start forming and due to pits leakage in base metal occurs. Sulphur ions- along with other Ions form concentric cells for Pits. Pit initiation already seen in ACC Chanda Bag House Corrosion rate of PITS is“UNPREDICTABLE” Ultimate result of PIT Leakage from the metal surface.

Internal Corrosion in RABH

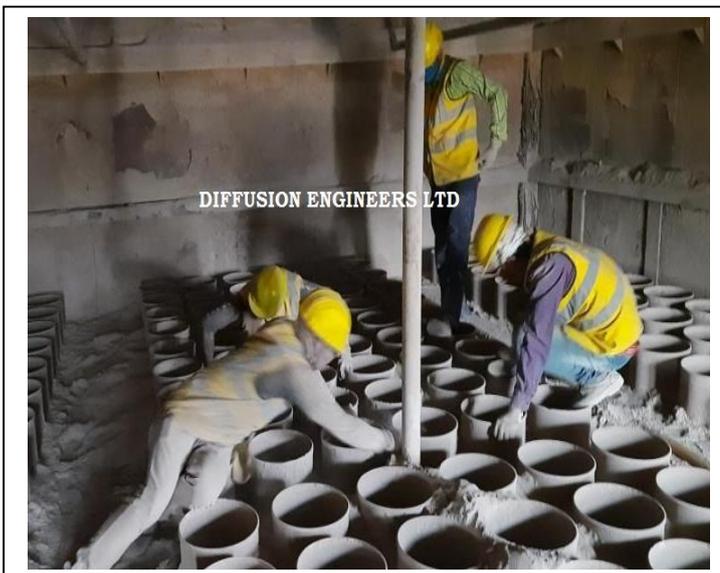
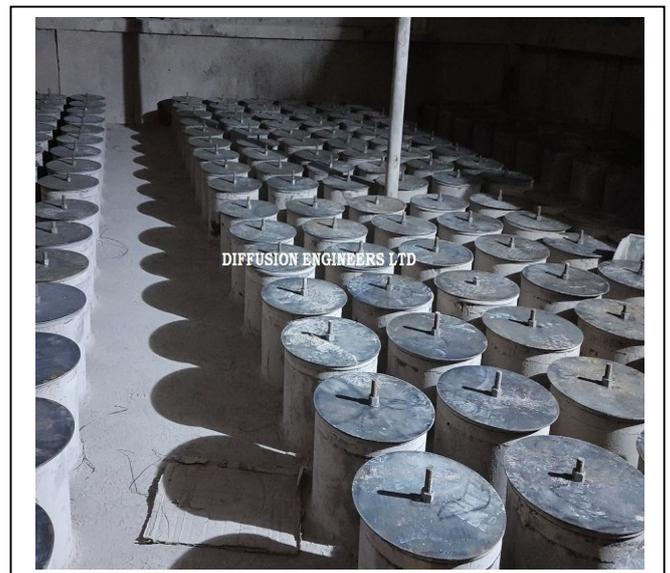
Removing of Bag Filters, Manual cleaning & installation of dummy plates on thimbals

1. Before application of any kind of coating surface preparation is must to activate the base metal so that coating will have better bonding.
2. Before started blasting work removed Bags fillter from inside bag house and dummy plate were installed on thimbals.
3. After manual cleaning, surface was cleaned by grit blasting to remove all loose particles. As per ISO standard surface prepration of SA 2 1/2 by blasting with surface profile achives of 70-90 microns.

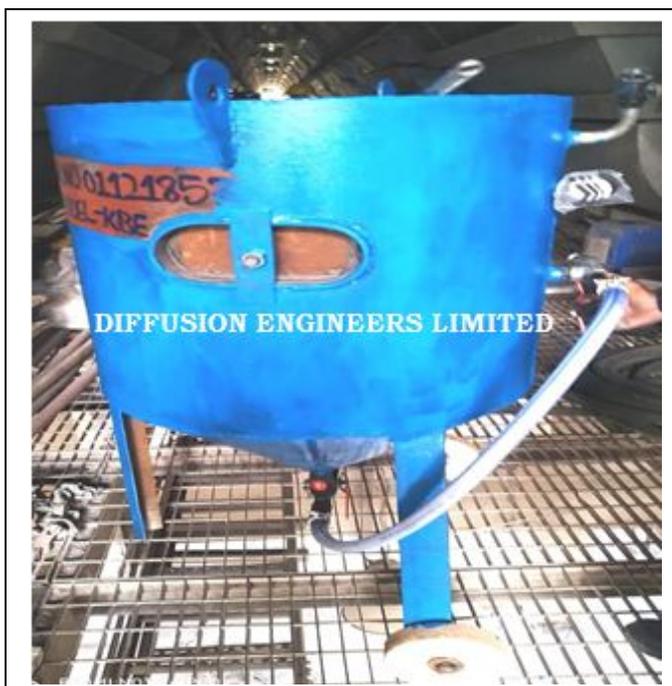
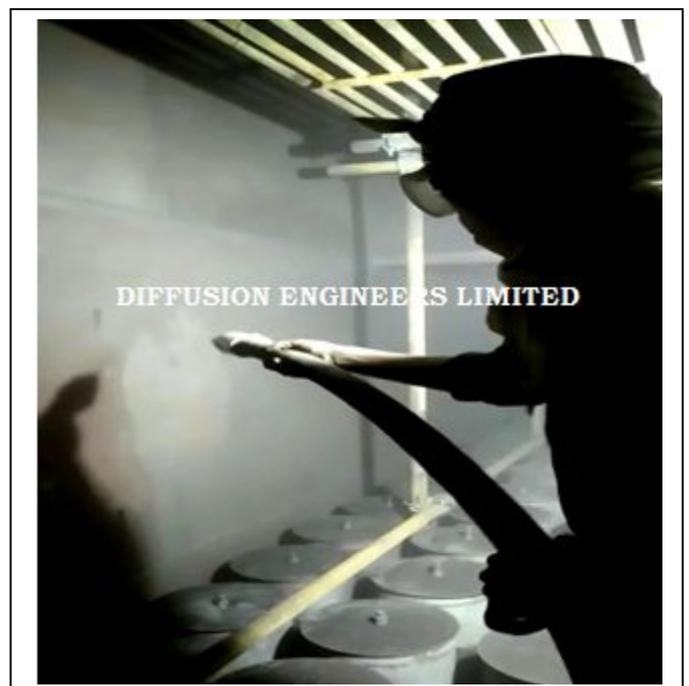
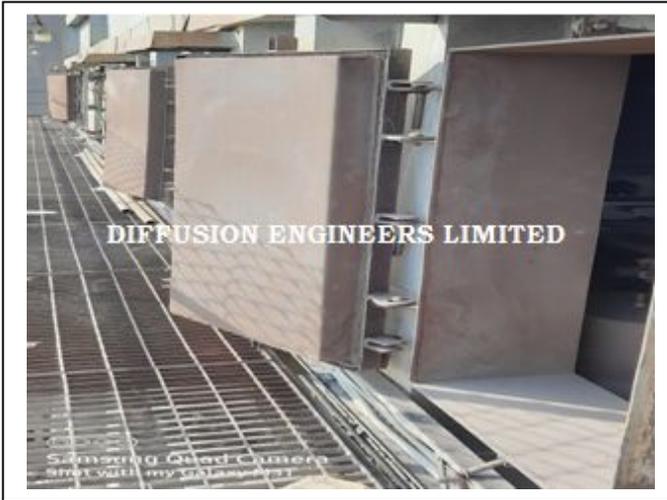
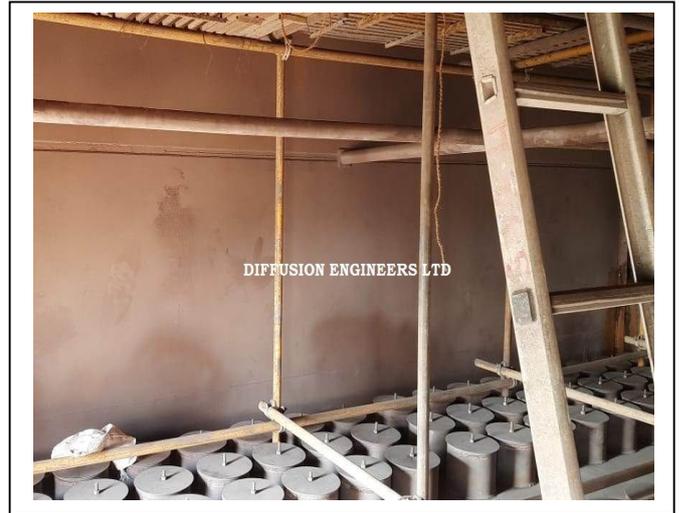
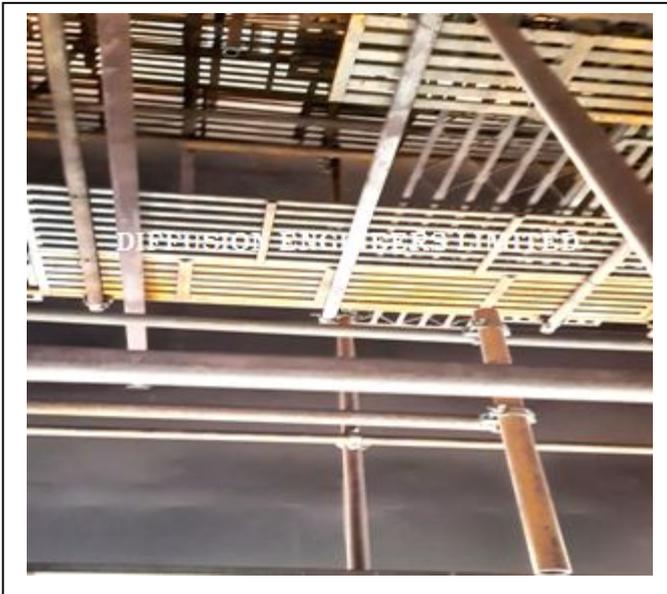
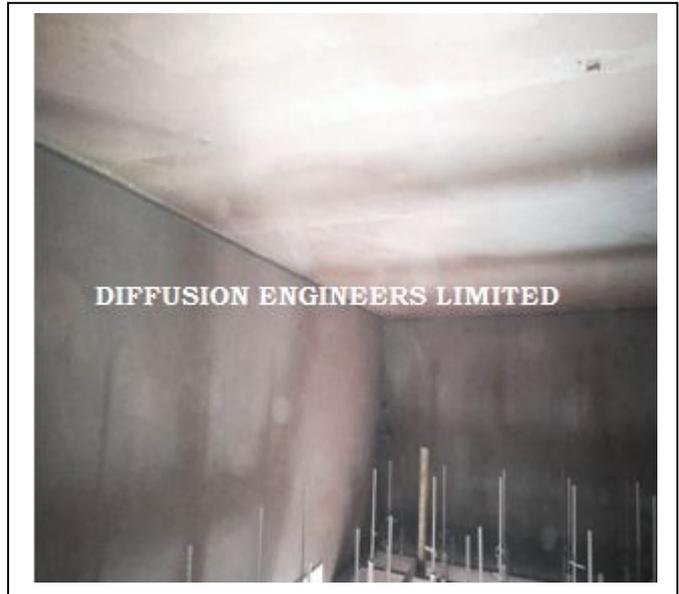
Surface Preparation done by Abrasive Grit Blasting

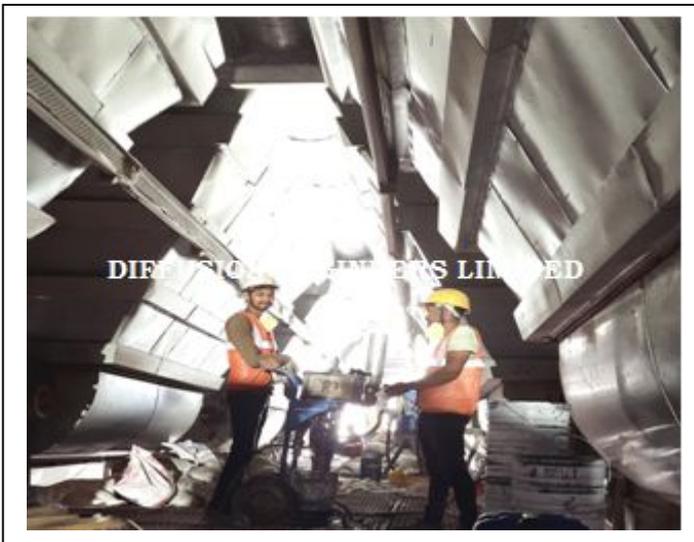
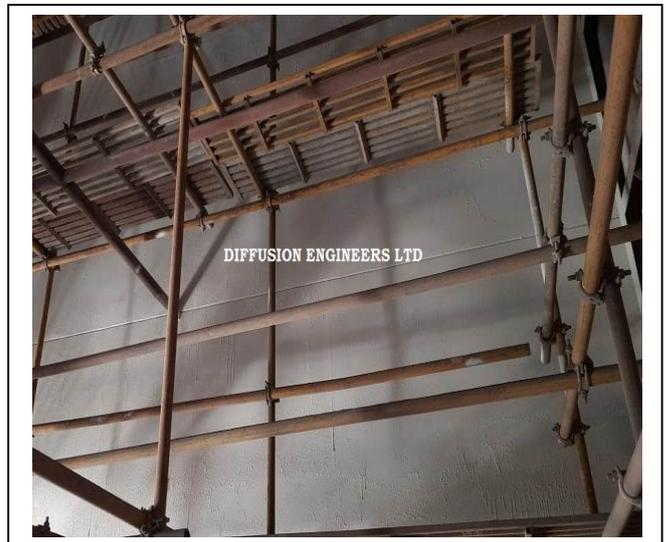
1.) After surface preparation priming was done by **DIFFGLASS XTREME** by used Airless spray machine.

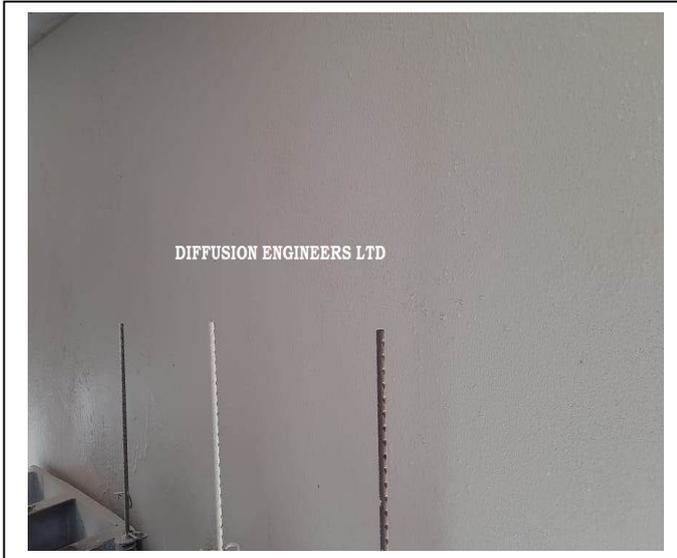
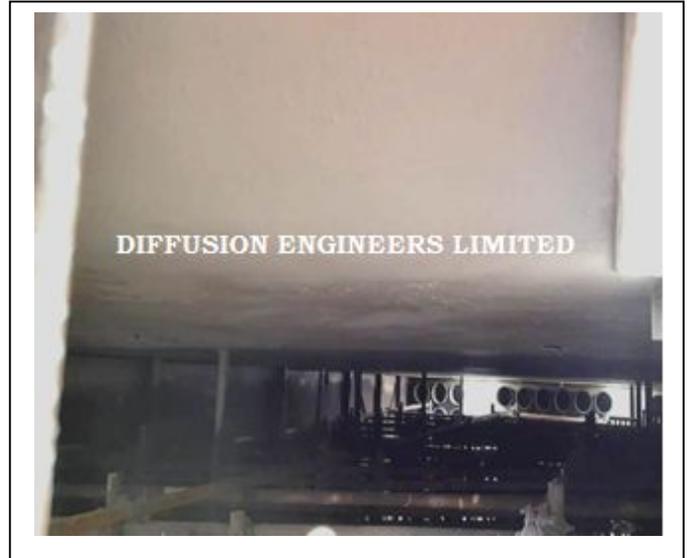
Fig. Application of DIFFGLASS XTREME as Top coat

2) To give corrosion resistance against top coat of **DIFFGLASS XTREME** was applied.

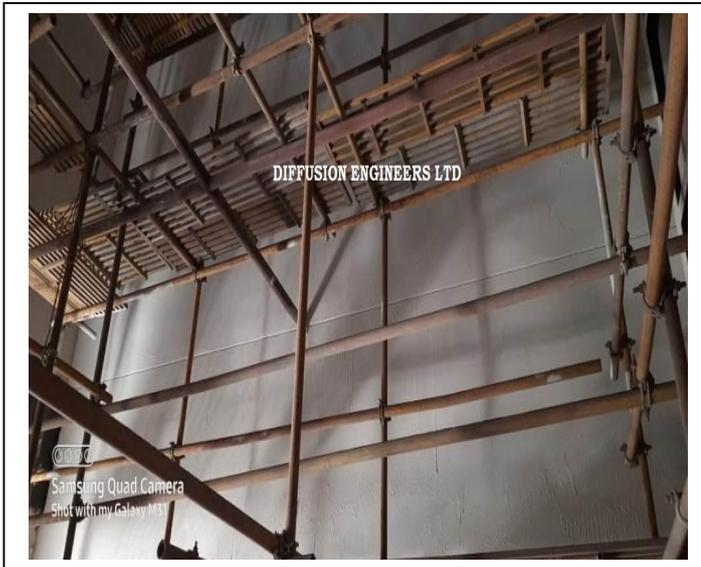
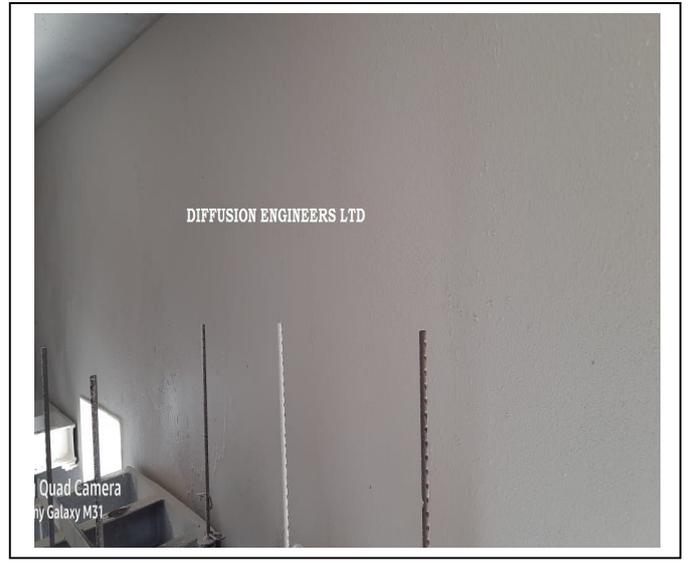
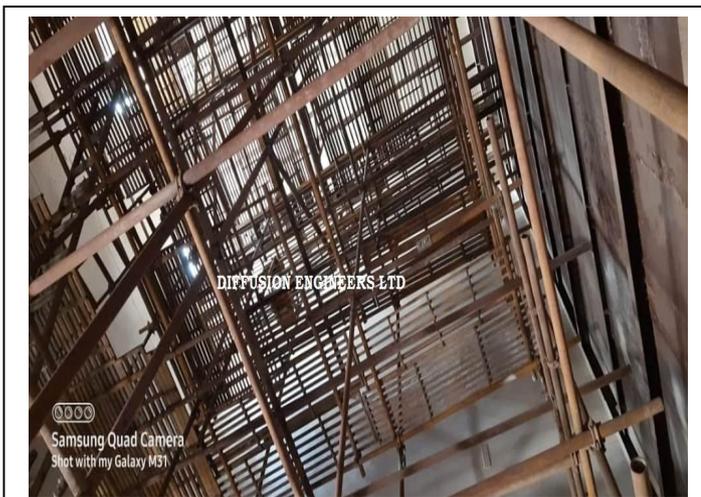
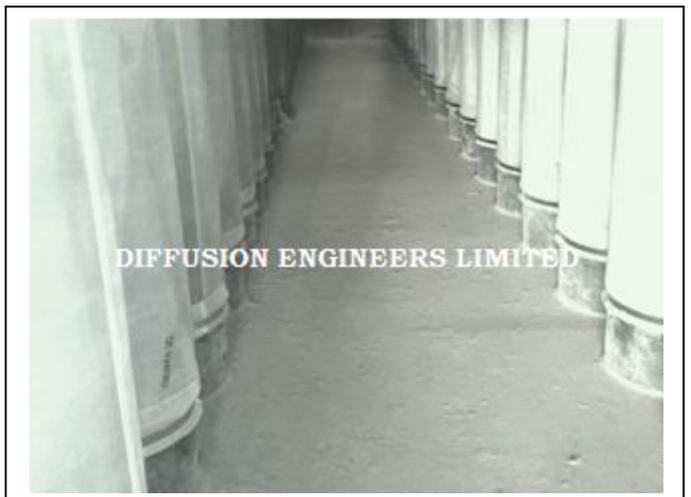
Final View of Coating:-

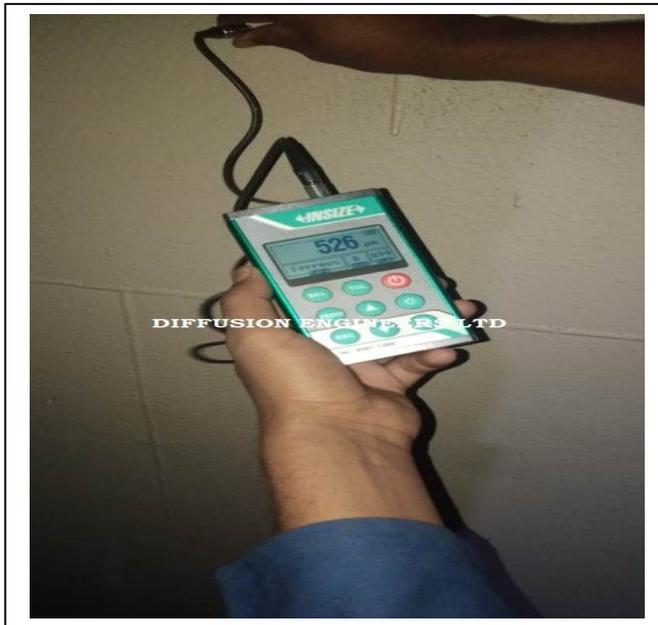
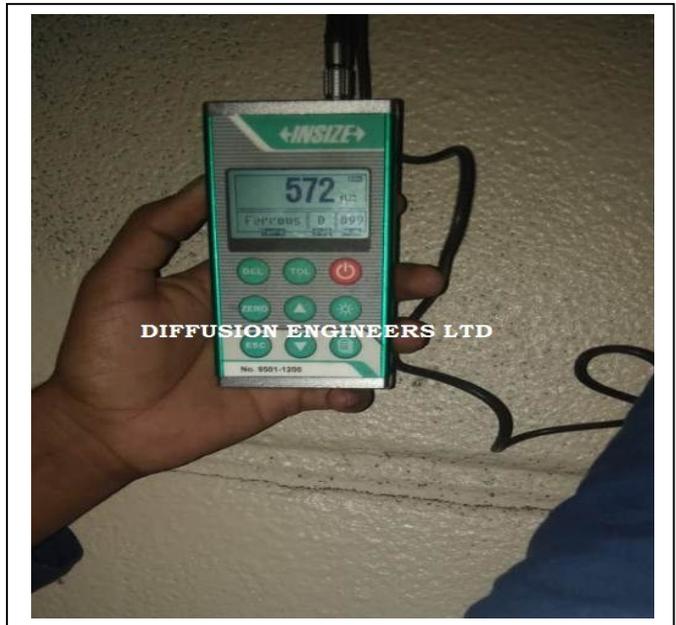
DRY FILM THICKNESS: - Range: 500- 600 (Micron)

DFT MESUREMENT by DFT
