REPORT NO: DCQ/NGP/2022-23/04

APPLICATION REPORT

INTERNAL COATING OF KILN INNER SHELL (LINE-3)

**BIRLA SHAKTI CEMENT,
DIVISION OF KESORAM INDUSTRIES LIMITED
UNIT: VASAVADATTA CEMENT, L N NAGAR, SEDAM
DIST: GULBARGA (KARNATAKA)**

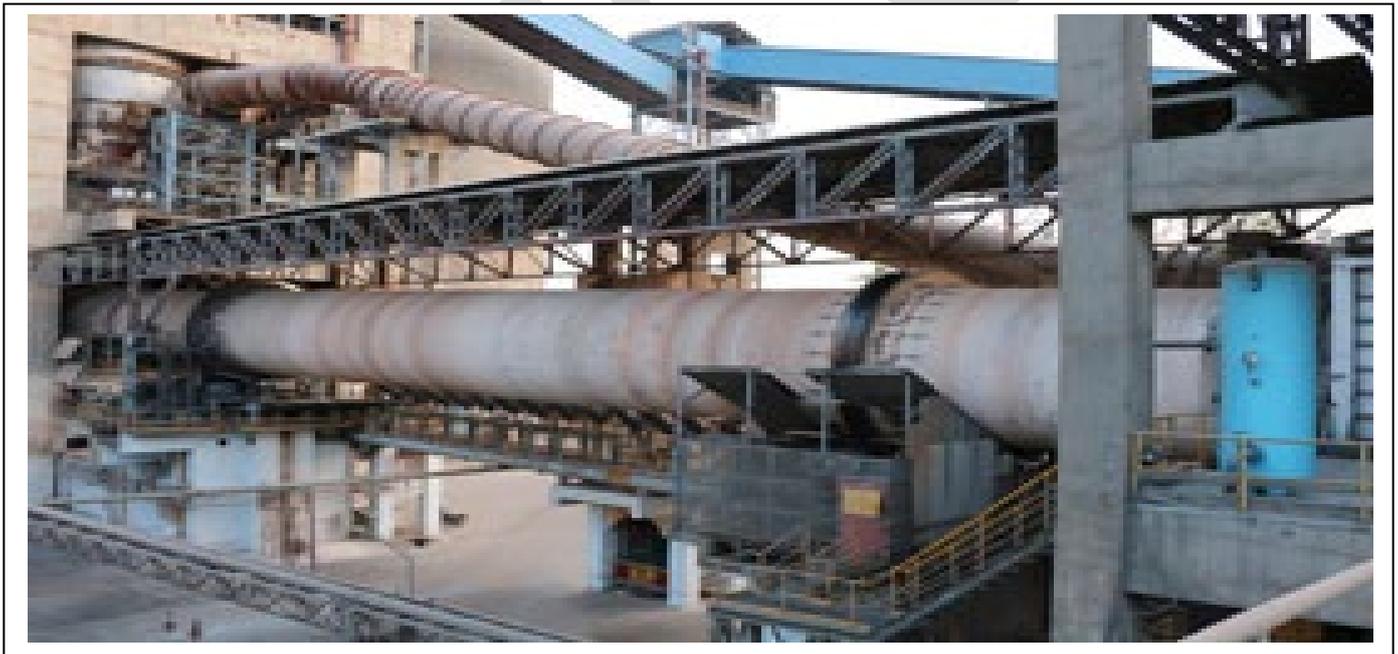
Kiln shell – The steel shell of the kiln is conically tapered at the ends and can also have other tapered sections. It experiences torsion due to the drive, and flexural stress due to its own weight as well as the weight of the lining and the charge. Because of partial filling and point wise support, the ideally circular shell cross section is deformed into an oval shape. The shell is designed in accordance with the laws of thin-shell statics or by approximation methods. Direct-fired kilns are typically made out of C steel. Indirect-fired kilns, however, are to be more resistant to high temperatures, and are hence made out of a more heat-resistant alloy.

Base Metal of Kiln shell: Mild steel

Diameter: 4.55 meter

Length: 56.00 meter

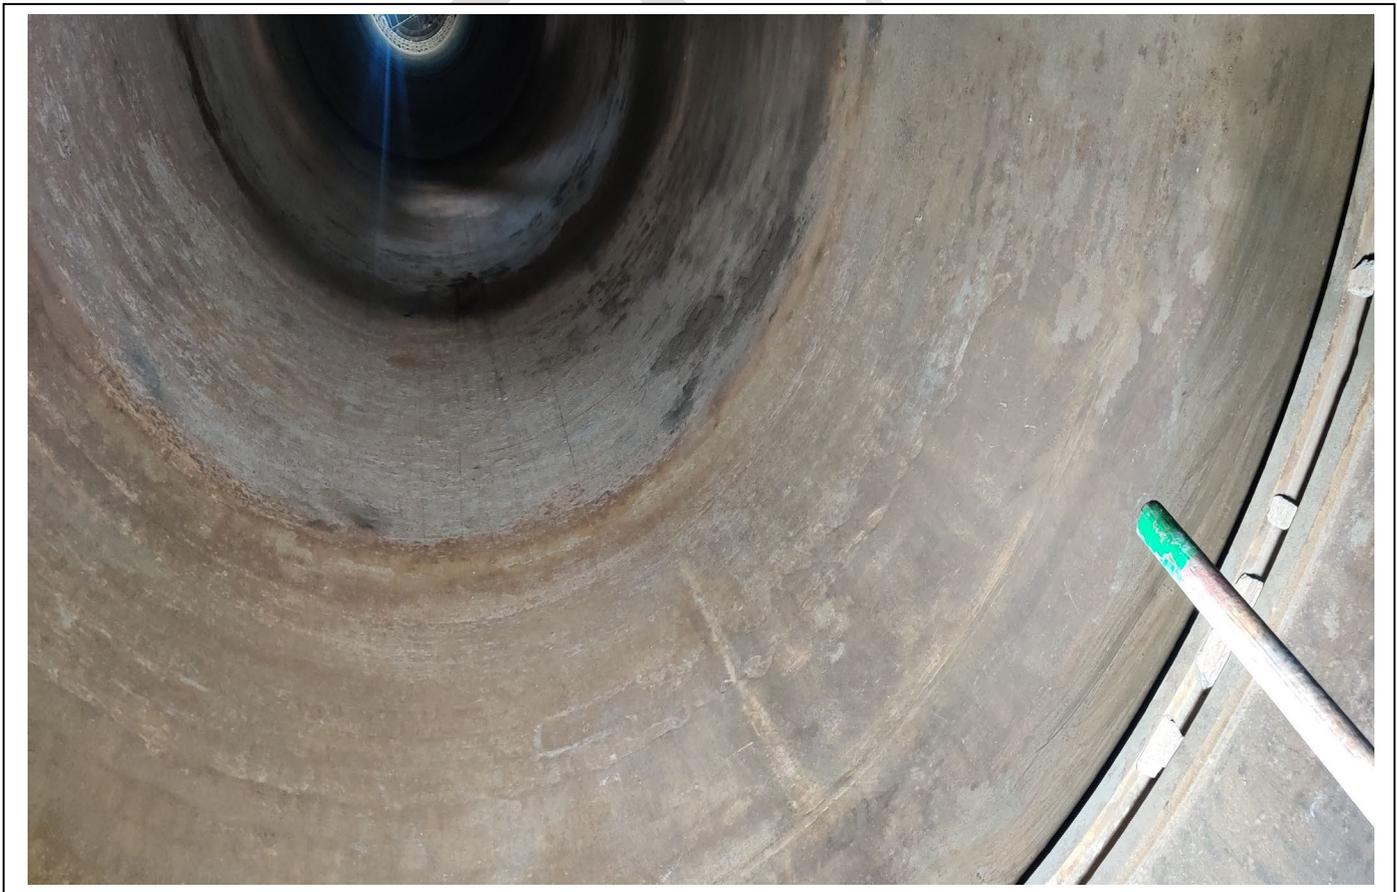
Corrosion of the rotary kiln shell behind the refractory lining has become an increasingly serious problem for cement industry as it acts silently and reduces the shell thickness to below critical structural and mechanical limits of stability of kiln shell. Understanding the factors influencing the kiln shell corrosion and its formation mechanism is the best way to inhibit it. Corrosion of kiln shell behind the refractory is influenced by a number of factors such as composition of the metallic shell and its environment, temperature of the shell, cleanliness or roughness of the shell surface, its contact with other materials and severe process conditions. Carbon dioxide and sulphur dioxide are active scaling agents of iron and steel. The main reason of shell corrosion can be attributed to alternate oxidation at high temperature and acidic reaction at low temperatures when the kiln is stopped for repairs. The corrosion phenomenon takes place mainly due to presence of oxides, chlorides and sulphide at high temperature. There are two different kinds of kiln shell corrosion are observed in cement kiln systems:

Fig. Corroded area of kiln inner shell

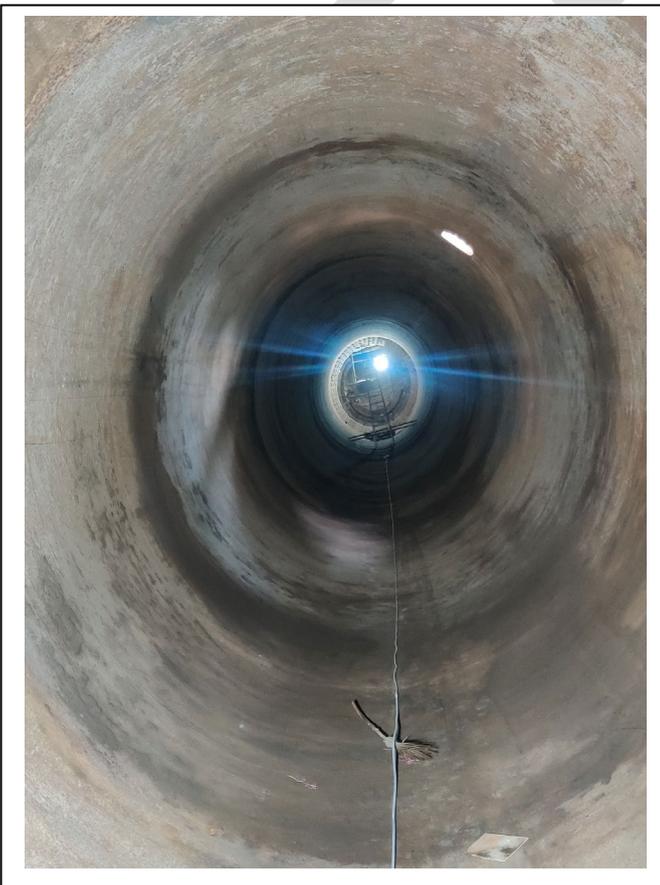
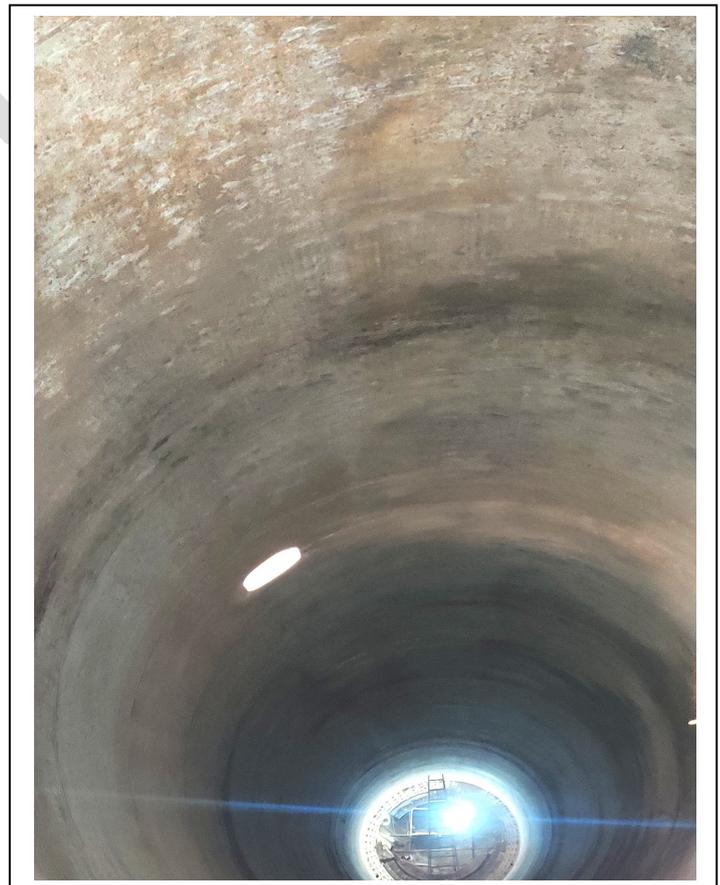
Fig. Surface Preparation done by grit blasting in kiln inner shell

1. Before application of any kind of coating surface preparation is must to activate the base metal so that coating will have better bonding.
2. After manual cleaning, surface was cleaned by grit blasting to remove all the loose particles. As per ISO standard surface preparation of SA 2 ½ by blasting with surface profile was achieved of 70-80 microns.

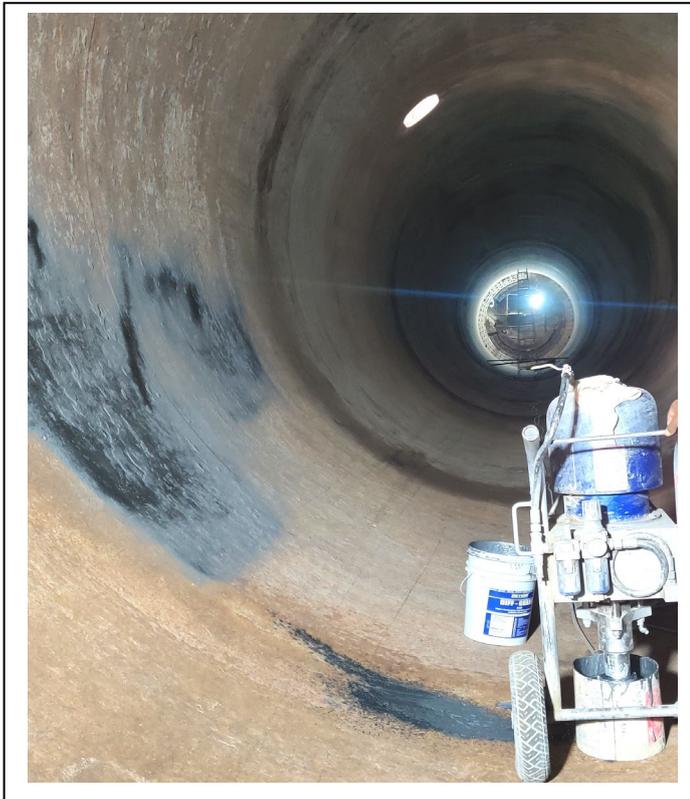
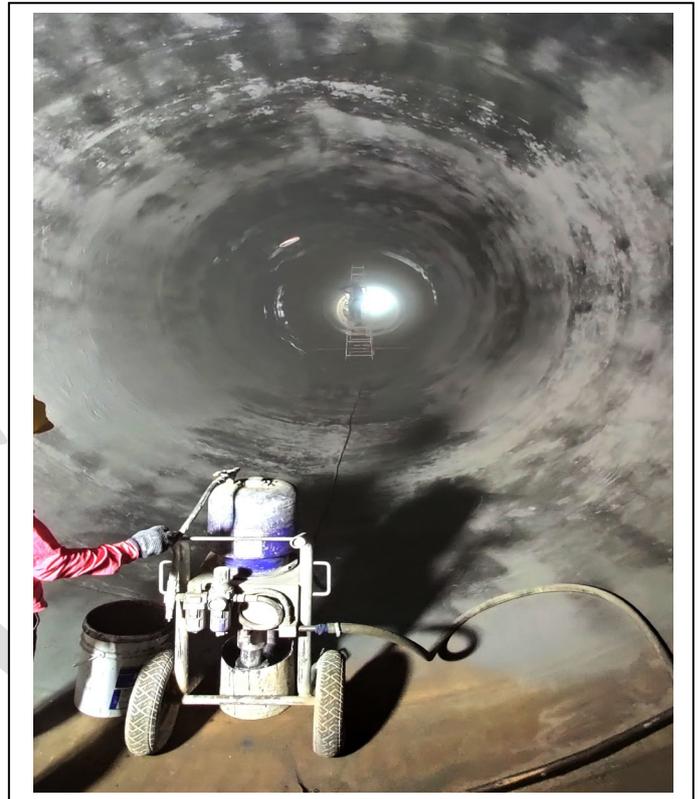
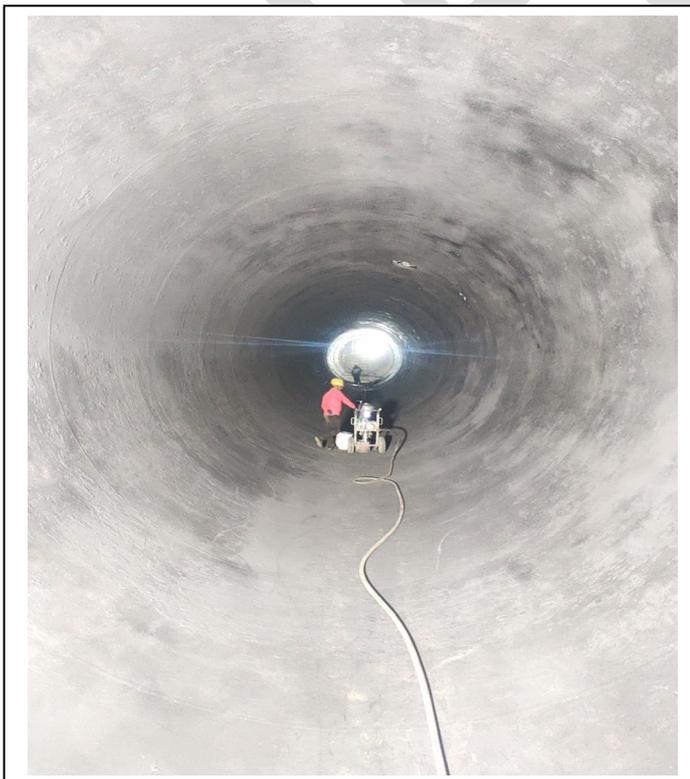
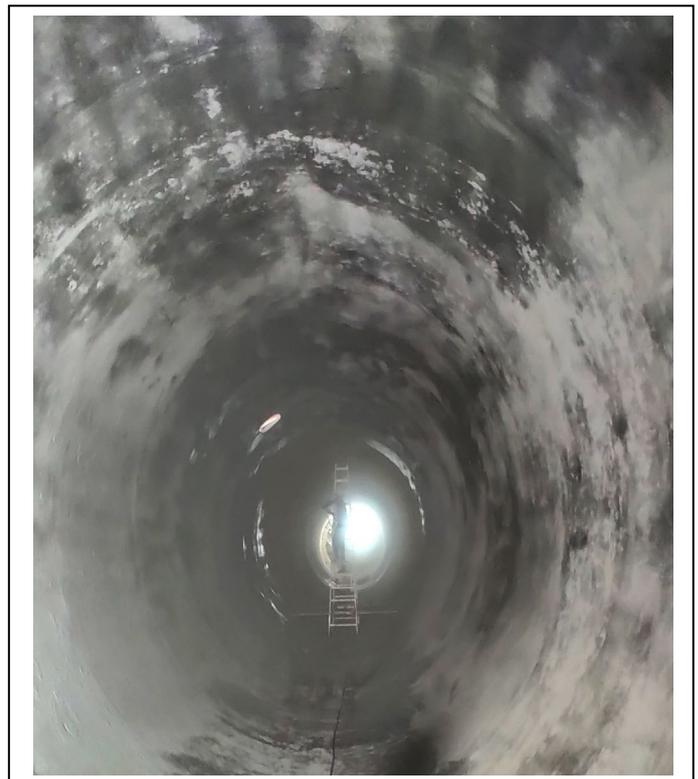
Fig. Application of DIFFGUARD HT

1.) After surface preparation **DIFFGUARD HT** was applied by airless spray with gun after that to increase the corrosion and Abrasion resistance.

The Dry film Thickness (DFT) was measured after final coat and reading was found @ 100-120 microns to all location of kiln inner shell.
