Case Study of Lime Stone Crusher Rotor Crack repair- In situ at Amrit Cement

Crusher Details

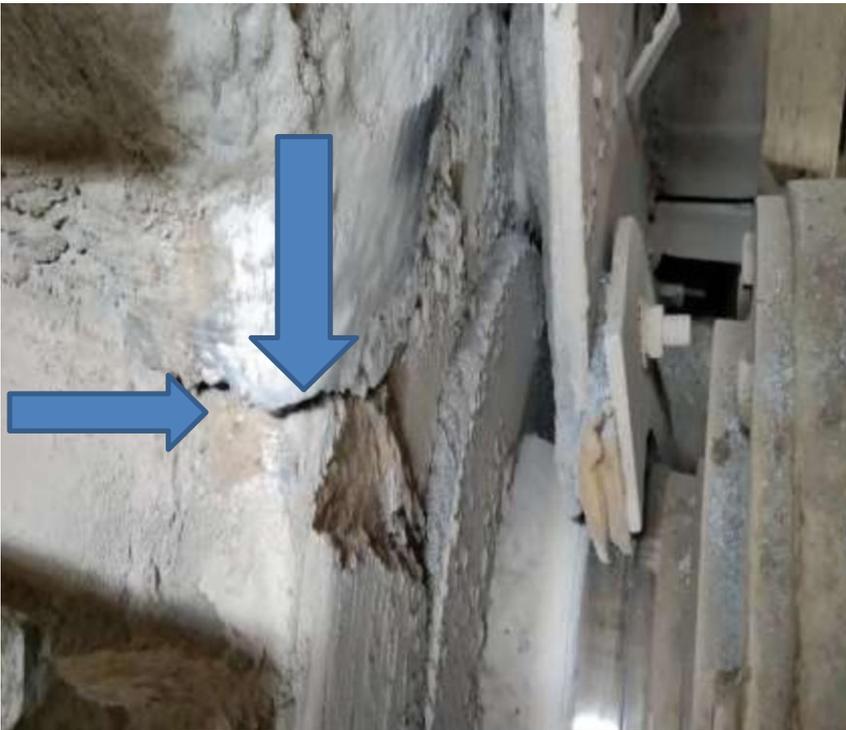
Crusher Damaged Portion

Through crack

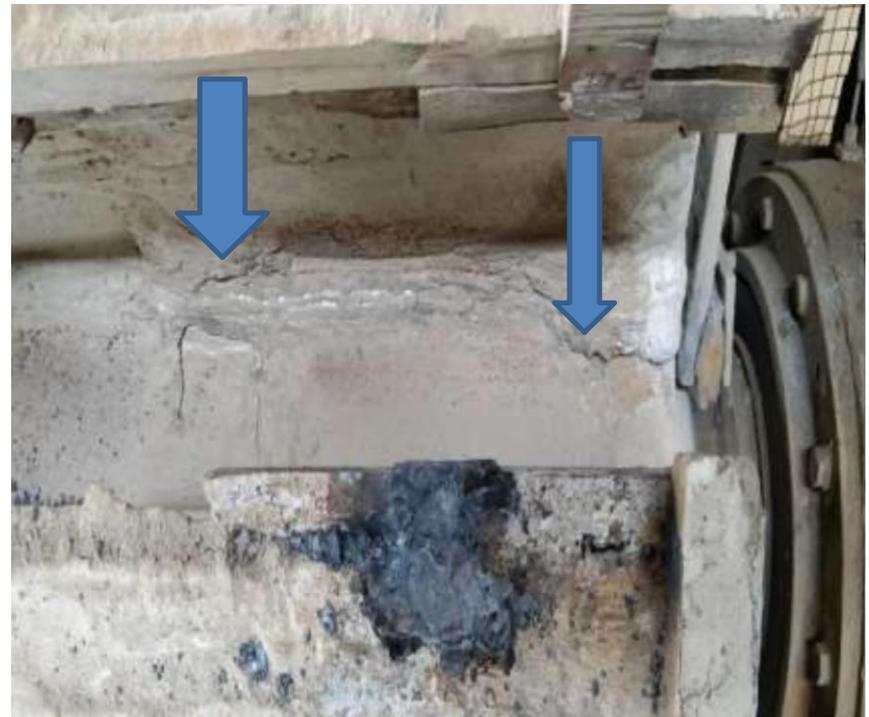
Through Crack in ribs
