## **APPLICATION REPORT**

### **INTERNAL COATING OF COAL MILL BAG HOUSE COATING**

**MURLI INDUSTRIES LIMITED A SUBSIDIARY OF DALMIA CEMENT (BHARAT) LIMITED VILLAGE NARANDA, KORPANA, DIST. CHANDRAPUR, (MAHARASHTRA)**

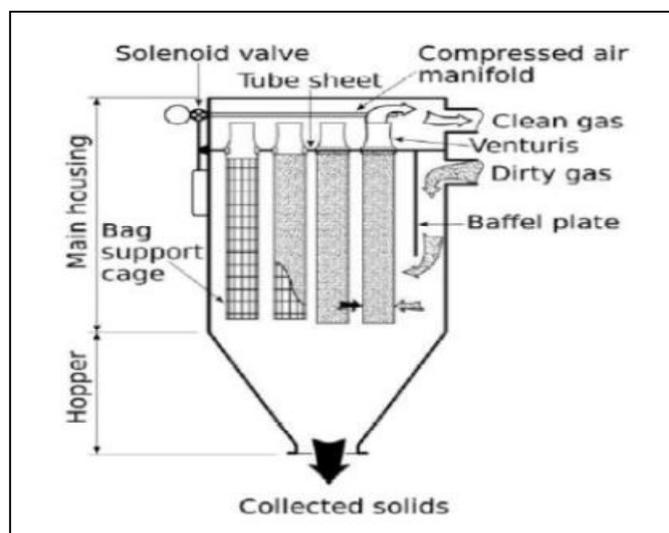
Pulse-jet (P/J) or reverse-jet baghouses use compressed streams of high pressure air to remove particulate matter. During cleaning, brief (0.1 second) pulses of air are pushed through the bag, dislodging solids which collect in a hopper below. The recommended air to cloth ratio for these baghouses is between 3.25:1 and 4.0:1.

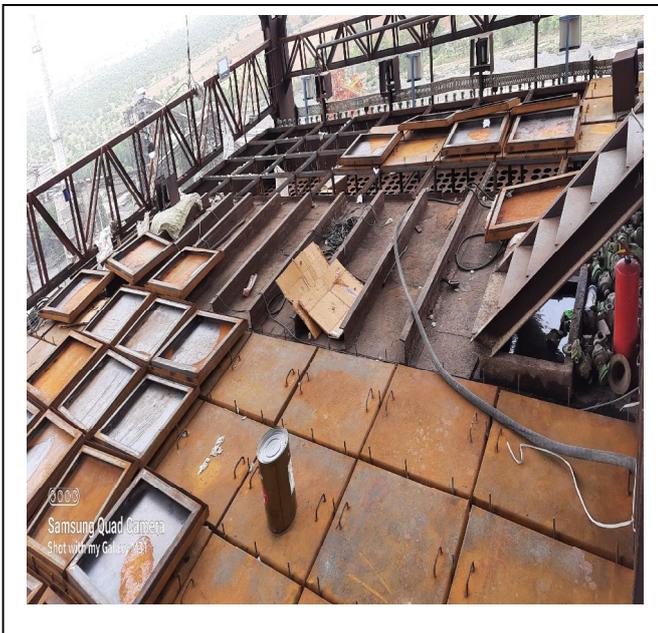
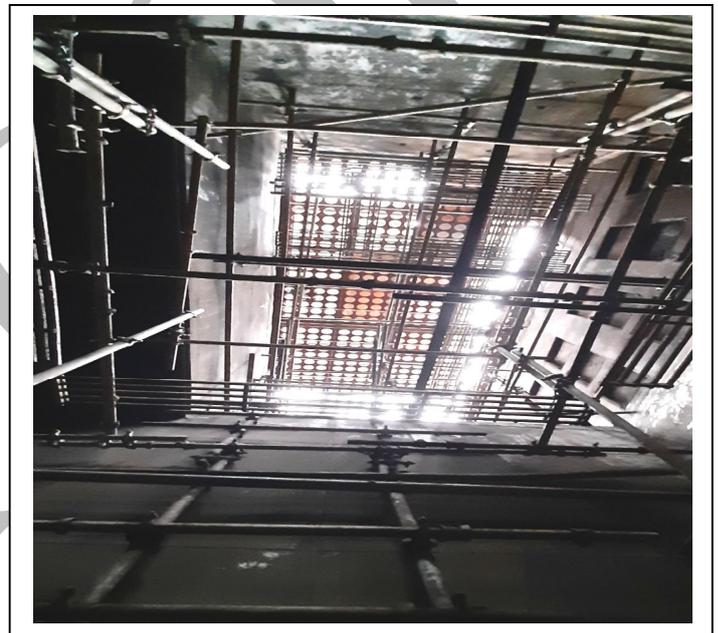
Customer was facing severe corrosion problem in bag house. i.e. Corrosion on the wall of bag house, Corrosion on the roof of the bag house Corrosion on the floor of bag house. Abrasion mainly happens when the flyash impinges on dry areas of the system, removing the thin layer of rust and exposing the steel to corrosion. This creates an abrasion/ corrosion vicious cycle. Corrosion takes place between dissimilar areas of metal where there are differences in electrochemical potential.

After a certain period, Pits start forming and due to pits leakage in base metal occurs. Sulphur ions along with other Ions form concentric cells for Pits. Pit initiation already seen in BAG HOUSE. Bag House Corrosion rate of PITS is "UNPREDICTABLE" Ultimate result of PIT Leakage from the metal surface.

*Fig. Internal Corrosion in bag house Air chamber, Air Duct, Purging pipes, tube sheet, doors and Hoppers*

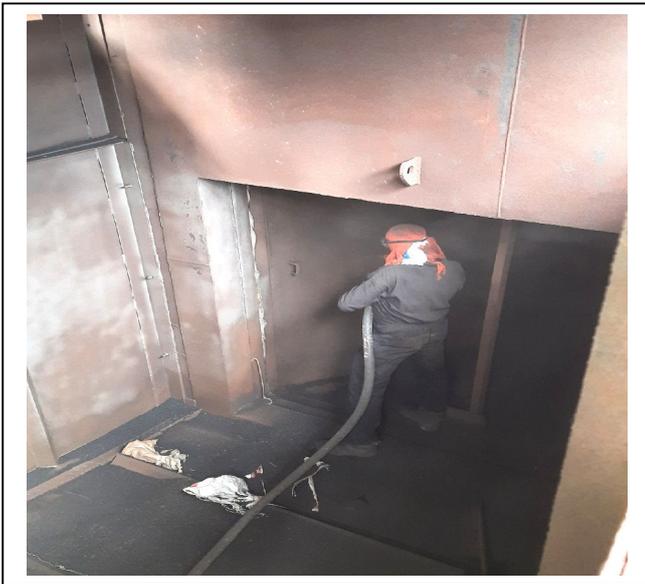
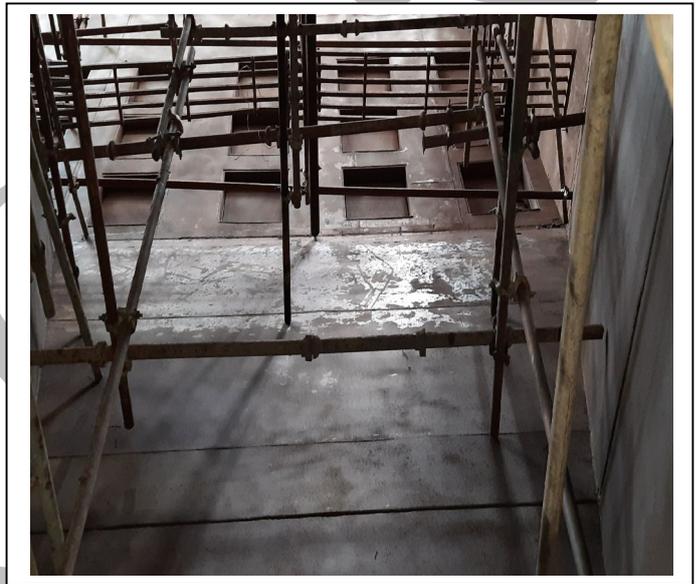
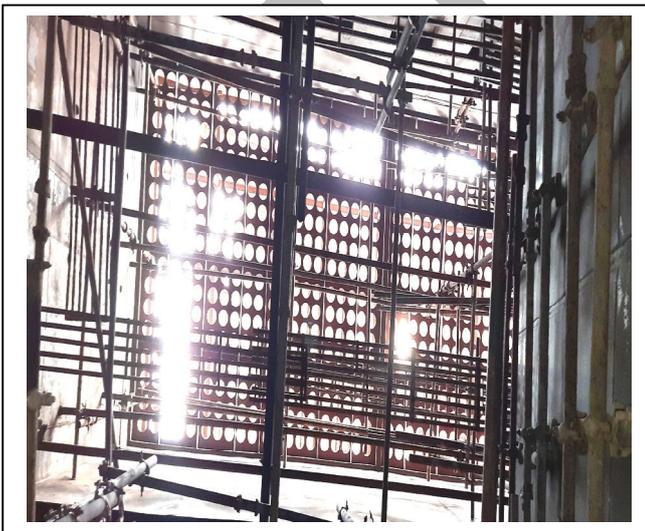
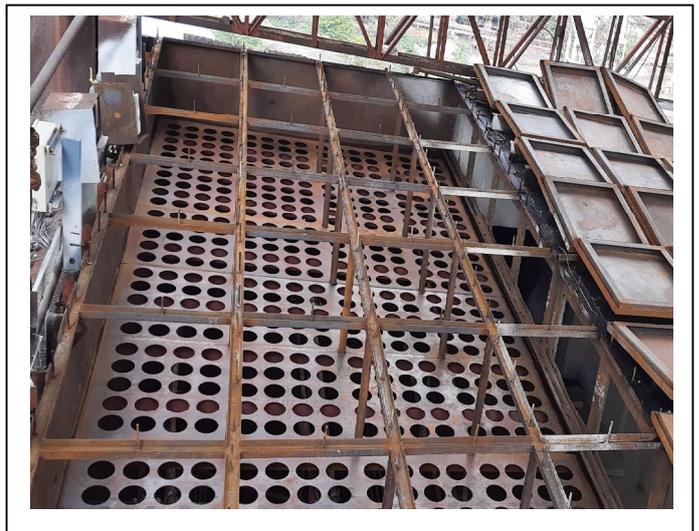
*Fig .Surface Preparation done by grit Blasting in bag house Air chamber, Air Duct, Purging pipes, tube sheet, doors and Hoppers*

1. Before application of any kind of coating surface preparation is must to activate the base metal so that coating will have better bonding.
2. Before started blasting work removed Bab fillter from inside bag house.
3. After manual cleaning, surface was cleaned by grit blasting to remove all loose particles. As per ISO standard surface prepration of SA 2 1/2 by blasting with surface profile achives of 70-90 microns.

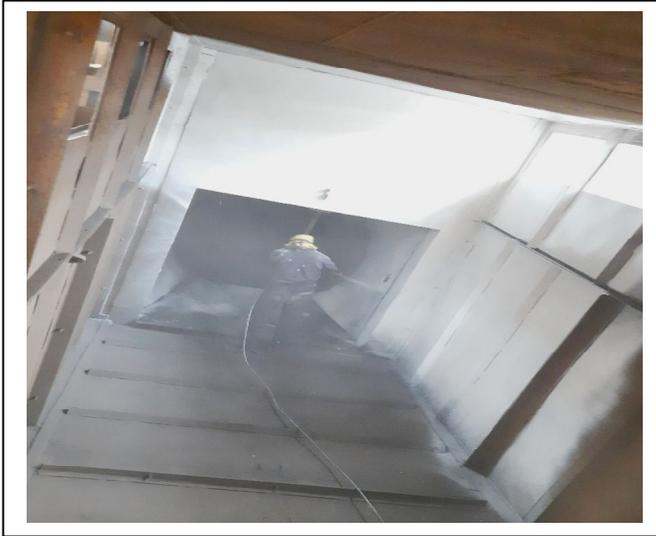
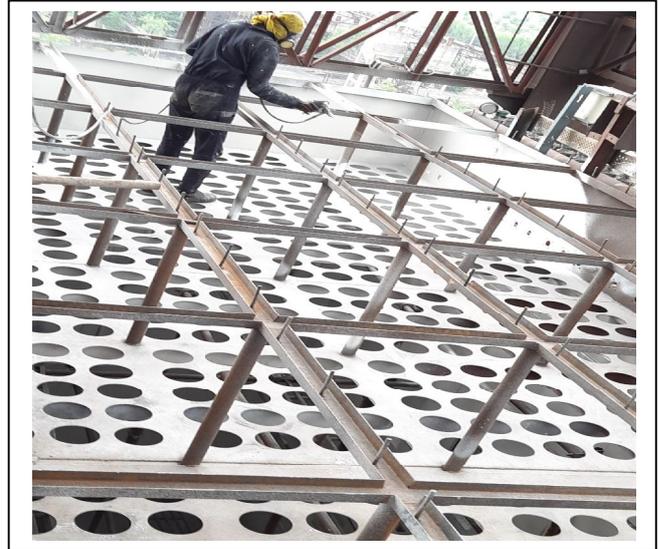
1) After surface preparation priming was done by **DIFFGLASS XTREME** by used Airless spray machine.

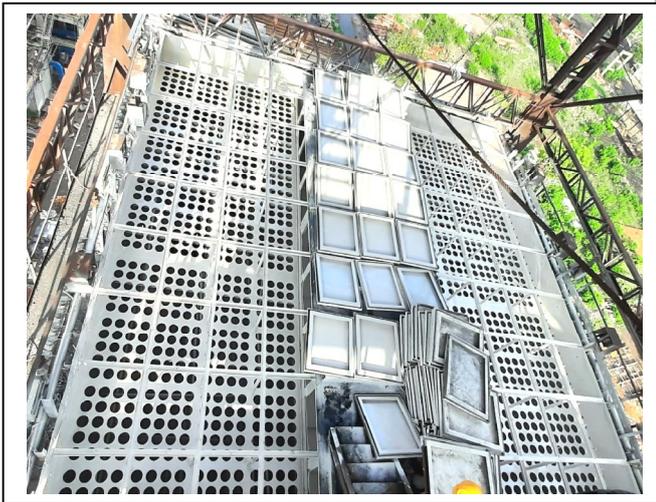
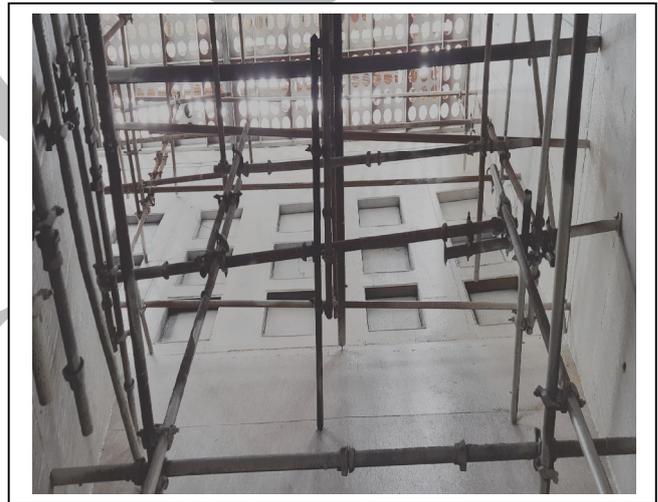
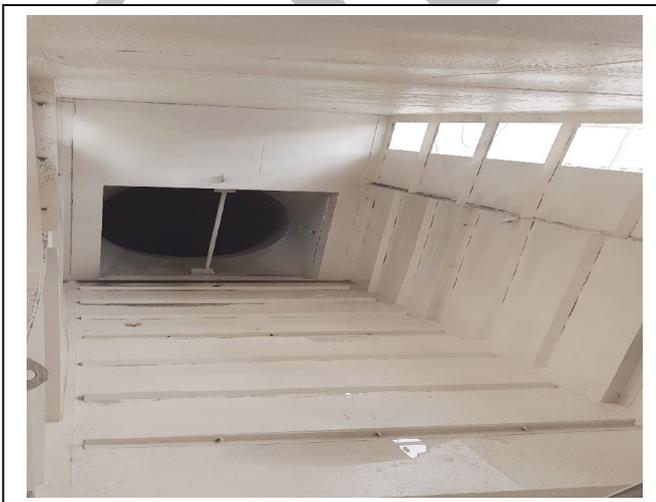
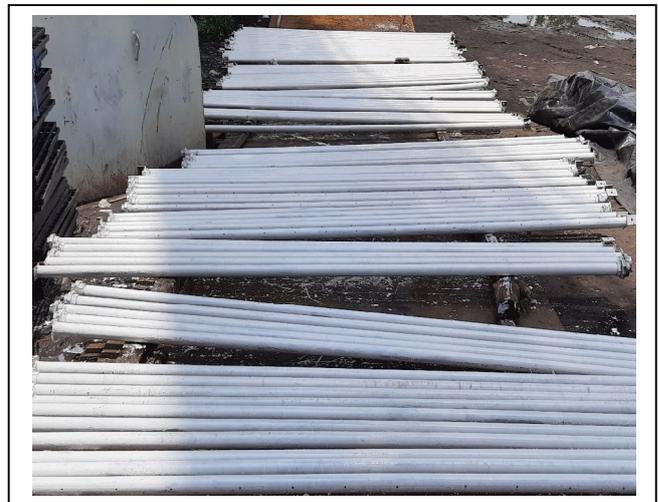
2) To give corrosion resistance against top coat of **DIFFGLASS XTREME** was applied.

***Fig. Application of DIFFGLASS XTREME***

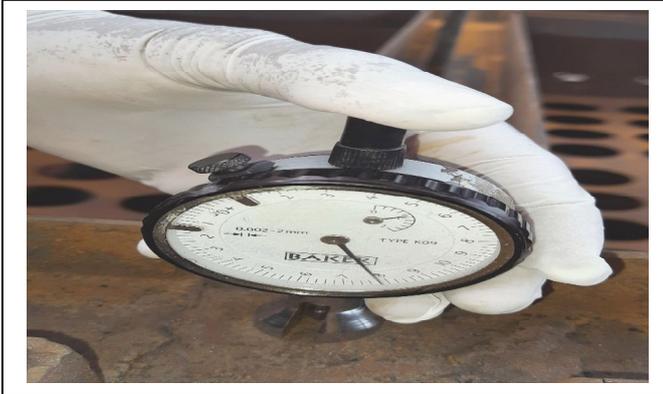
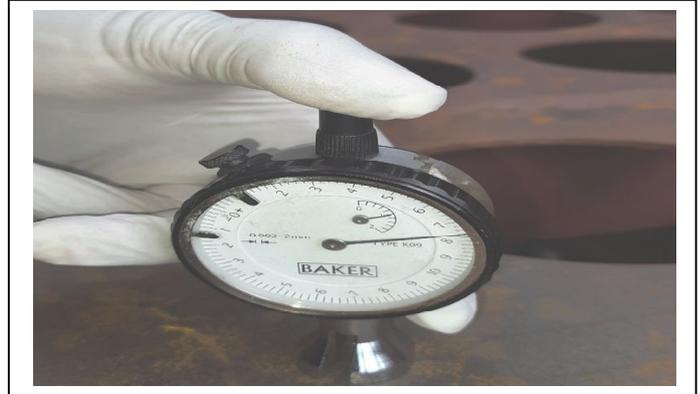
### 1) SURFACE PROFILE: Range: 75-90 (Microns)

*Fig. Blasted surface measurement by Profile Gauge*

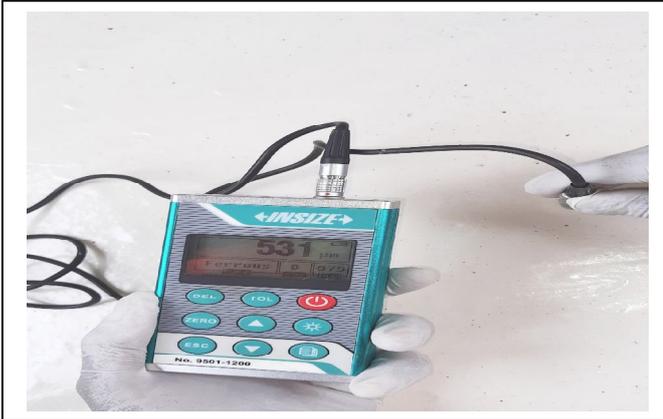
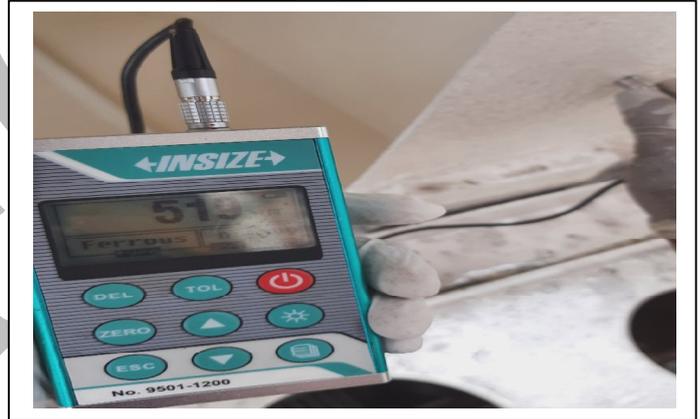
### 2) DRY FILM THICKNESS (DFT): - Range: 500-600 (Microns)

*Fig. coating Thickness measurement by DFT Meter*
