# **“REPAIRING OF CONVEYOR BELT”**

**ULTRATECH**

**DIFFCOR**

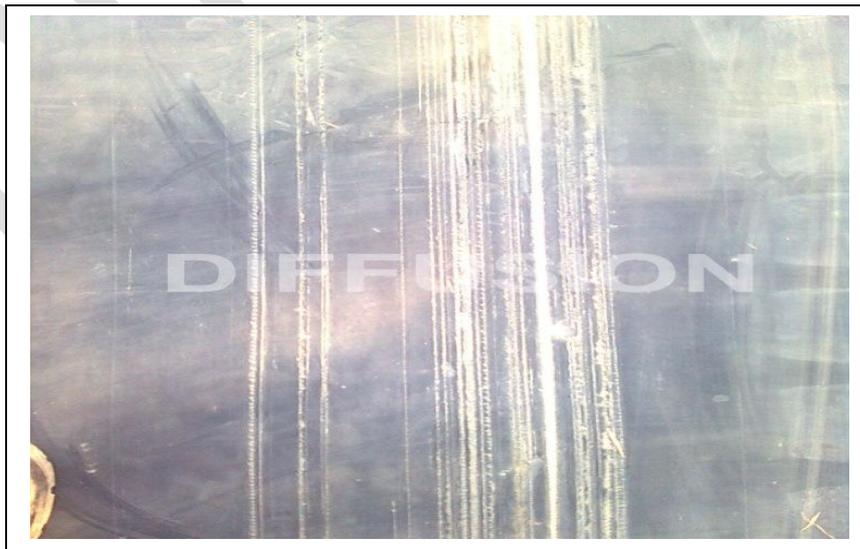
The belt damage consisted of a deep gouge along the entire length of the 460 foot belt. It was 5.5 inches wide and varied in depth. The belt is, 460 foot, 48 inch wide, fabric carcass with 4 plies. The damage went through the first two layers of fabric, and the third layer was exposed and deteriorating rapidly due to the highly abrasive nature of the material conveyed. The belt would need to be replaced within 3–6 months unless the protective rubber layer could be repaired. Replacing of belt was very costlier.
